Rogers Home Inspections

Property Inspection Report

206 Covington Dr, Wylie, TX 75098
Inspection prepared for: Zach Costa
Date of Inspection: 12/27/2017 Time: 8:30
Age of Home: 2017 Size: 2,064
Weather: Overcast, 40°F

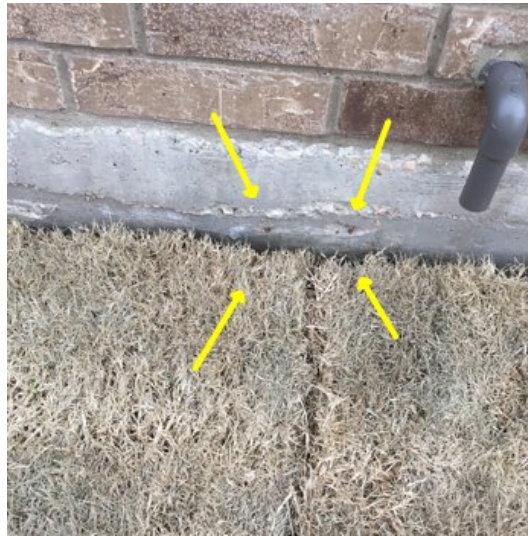
- **NOTE: Weather conditions, drainage, leakage and other adverse factors are able to affect structures and differential movements are likely to occur. The Inspectors opinion is based upon visual observations of accessible and unobstructed areas of the foundation at the time of inspection. Future performance of the structure cannot be predicted or warranted**
- The foundation appeared to be supporting the structure in a satisfactory manner at time of inspection
- **Steel reinforcement visible and beginning to rust at multiple locations around foundation. This should be sealed to stop the contact of the reinforcement to moisture which could cause it to deteriorate.**

Exposed reinforcement

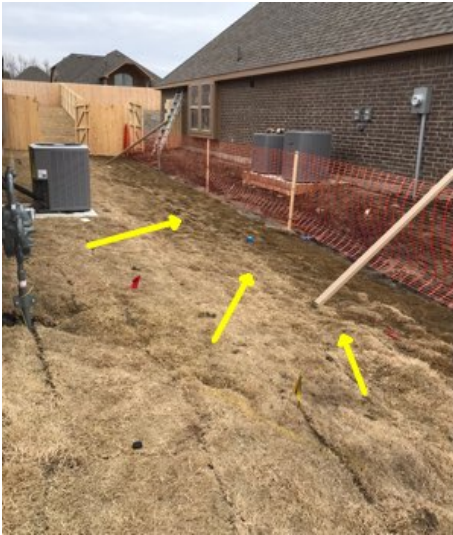
- **Visible minor erosion observed around perimeter**
- **Excessive moisture noted at one or more areas around the structure structure**
- **No gutter systems were observed and should be considered**

Excessive moisture located on east side of property

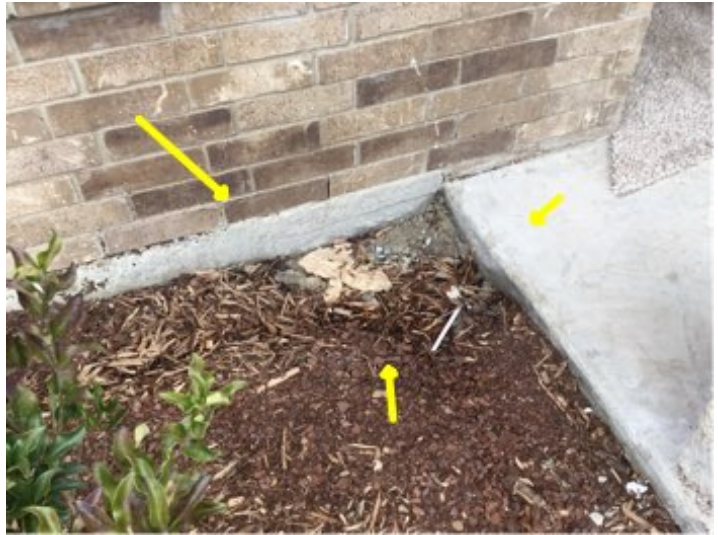
Washout from roof run off observed, gutters not installed

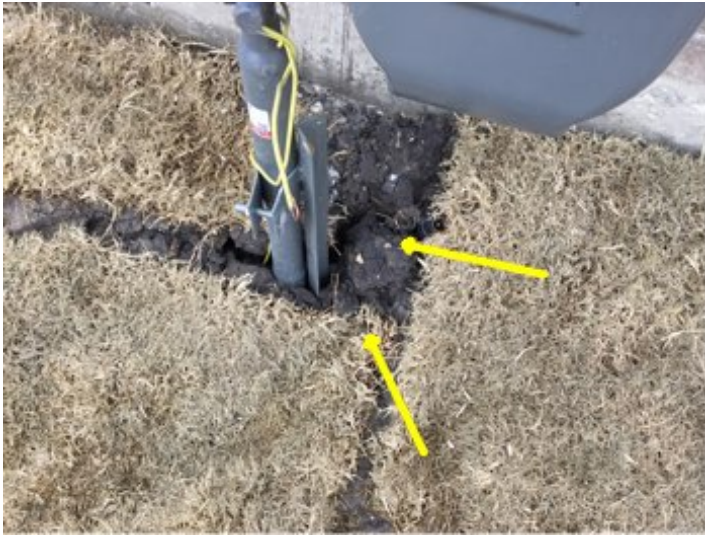
Loose and missing soil around gas meter causing irrigation pipes to be exposed

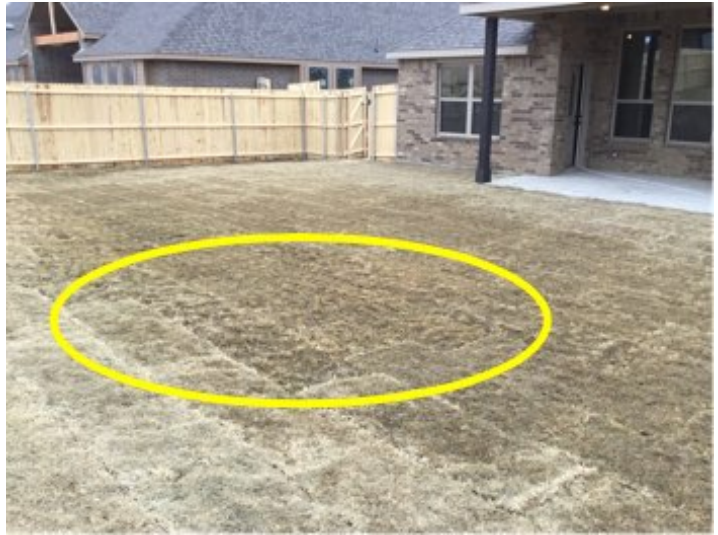
Excessive moisture observed in back yard, no drain installed

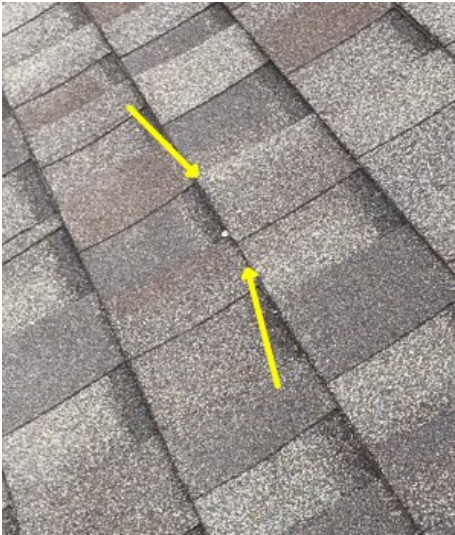
- The home was not equipped with gutters
- Debris (nails and pieces of cut shingles) left on roof.
- Exposed nails without sealant exposed on shingles and vents.

Exposed nails on shingles with sealant, could leak

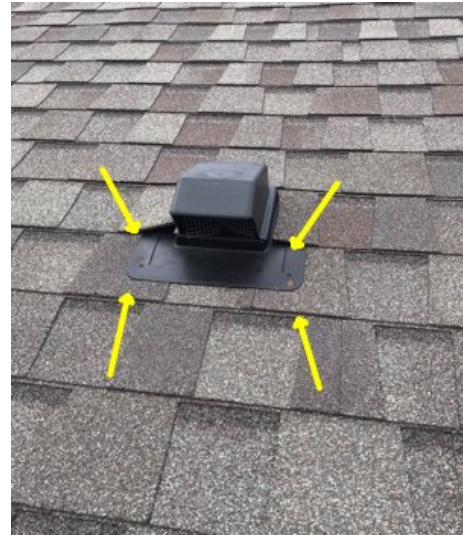
Unsealed nails on vents, could leak

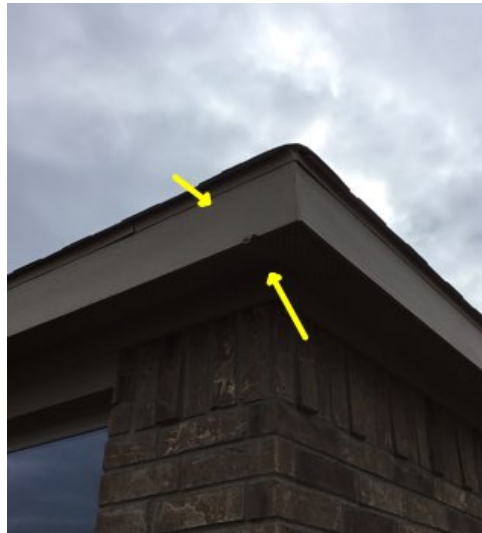
- The fascia board has some deterioration on more than one location on the structure

Damaged fascia

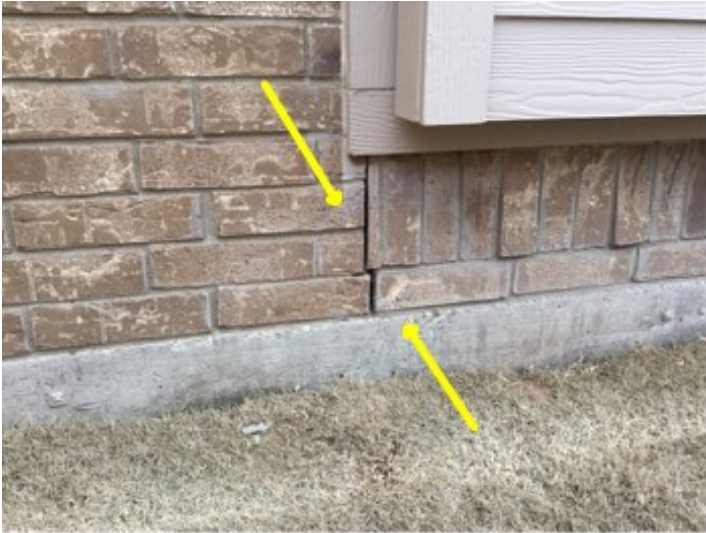
- The exterior veneer / cladding has some deterioration and/or damage
- Unpainted areas are visible

Large gap observed below window on west side of home

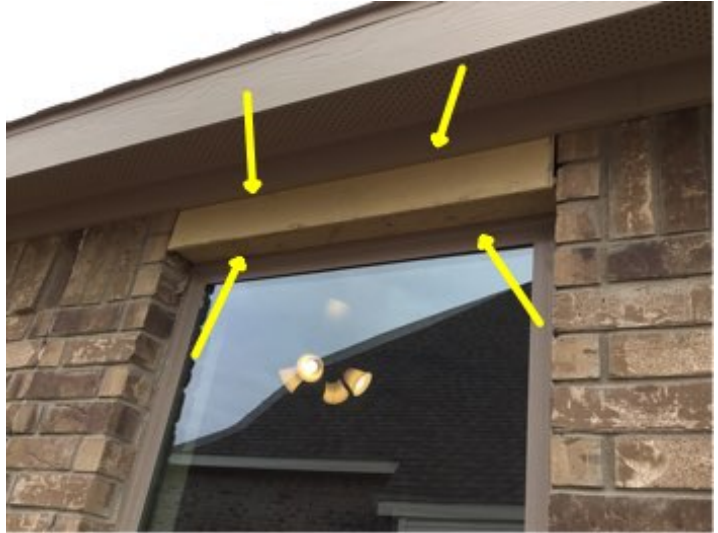
Area above window missing paint and caulking

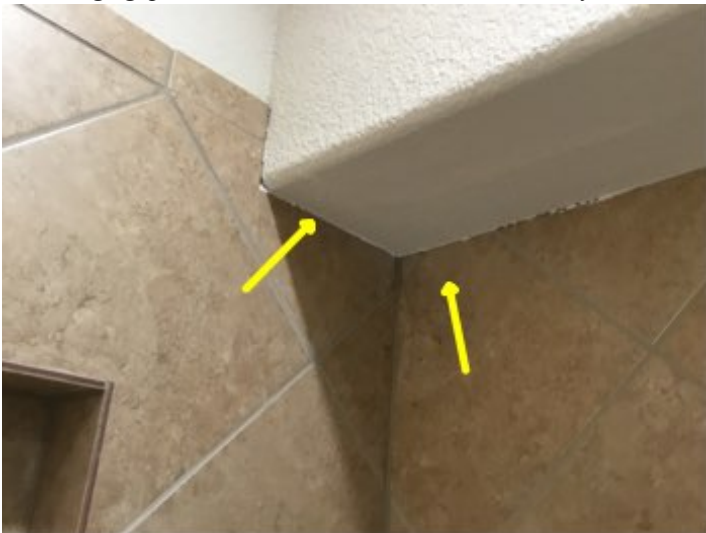
Missing caulk in master bath which could lead to moisture intrusion

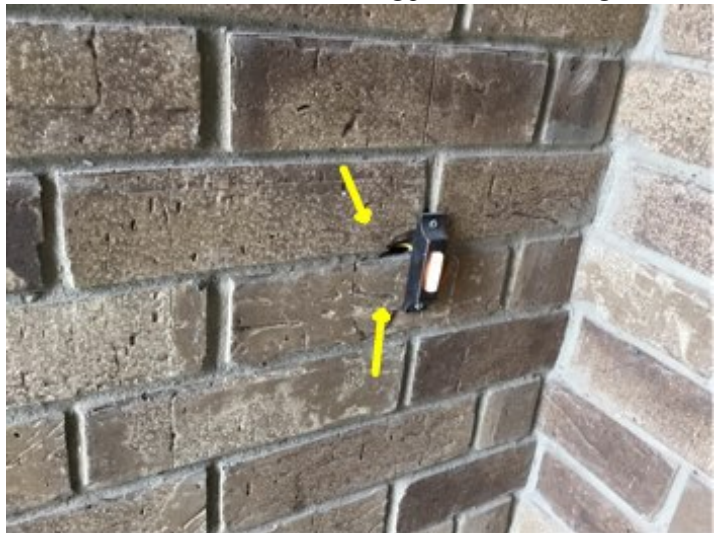
Hole around doorbell

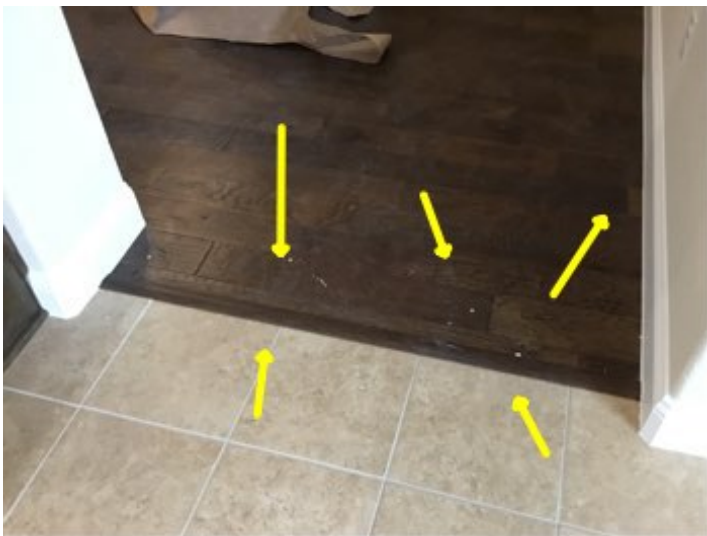
Spilled paint and overspray observed in many areas of the home

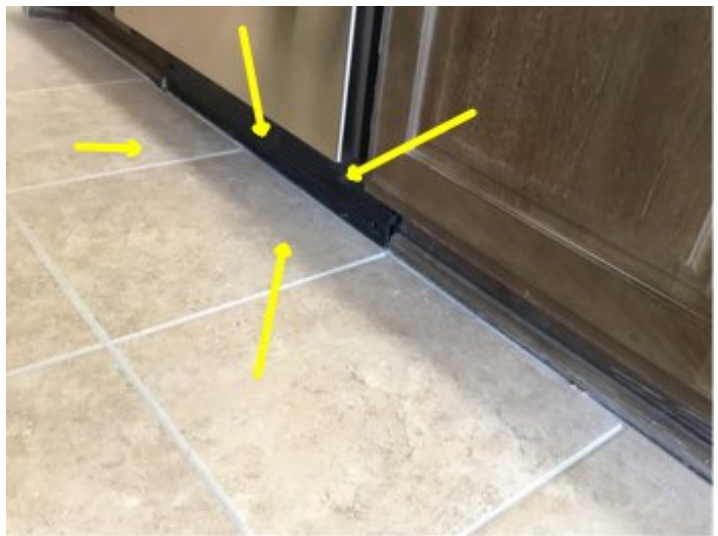
- Slab not visible due to floor coverings
- **Gap in between tile and trim beneath kitchen sink**

Gap between trim and tile beneath sink

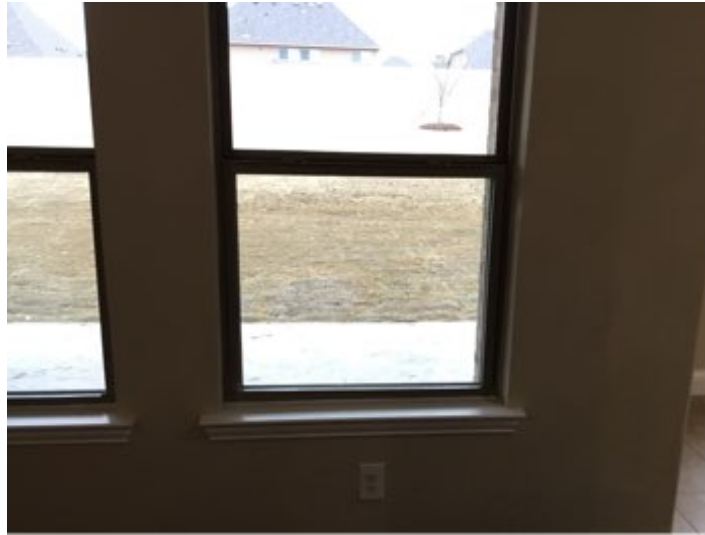
- **One or more of the windows were observed to be difficult to operate**

Some windows through house were difficult to operate, many need adjustments

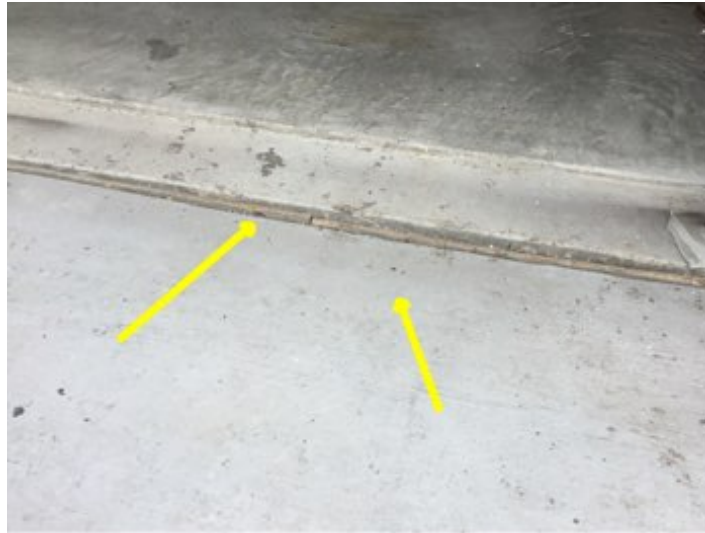
- Concrete sidewalks were noted
- Trip hazards were observed on the porch and/or deck surface and should be corrected for safety reasons

Trip hazard location between garage and driveway

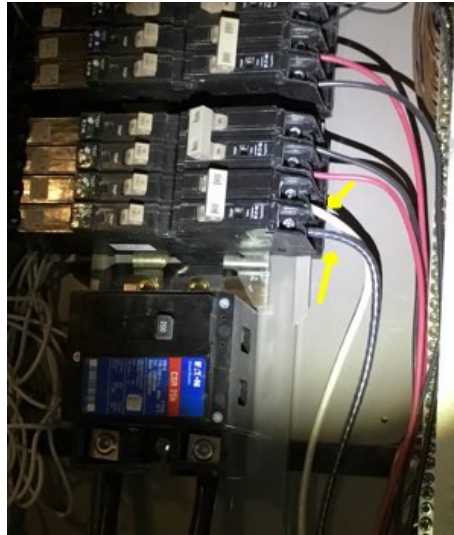
- Service entrance wiring is underground
- **There are white wires in the panel that should be labeled as hot wires**

White wire used as hot wire should be marked as a hot wire for safety

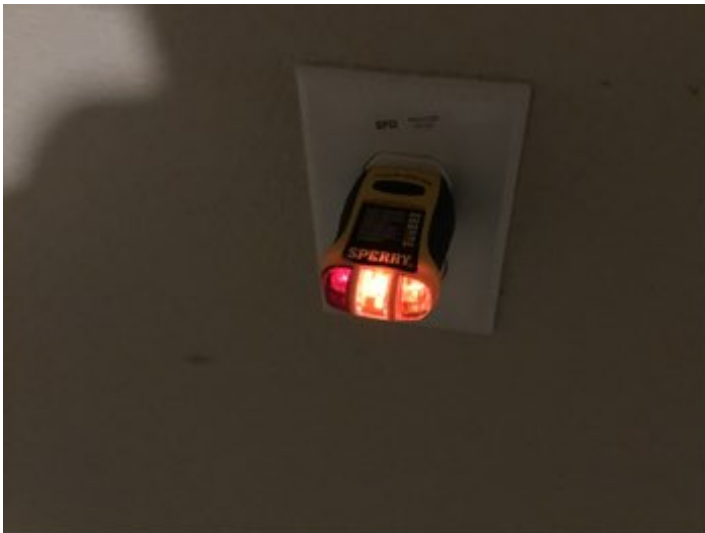
- The doorbell {s} was functional at the time of the inspection
- The **GFCI** (ground fault circuit interrupter) breaker is not properly functioning
- One or more receptacle and/or switch covers were missing and is considered a Safety Hazard

All lights on plug tester lit up and GFCI would not trip in garage outlet

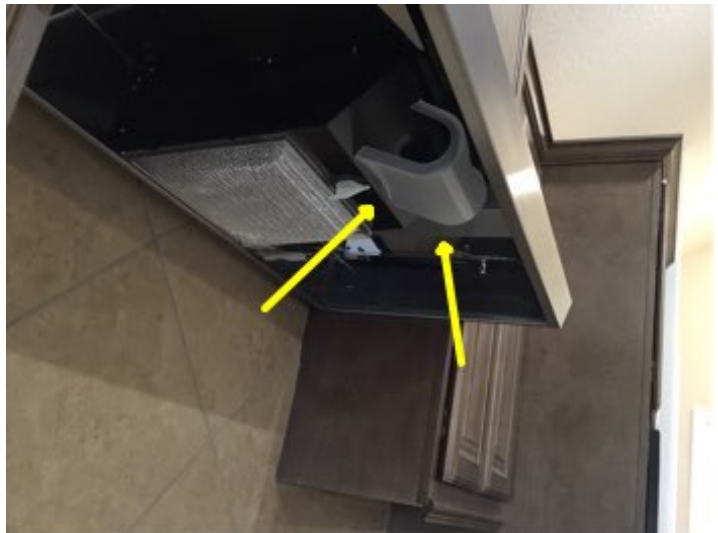
Missing bulb in stovetop vent fan

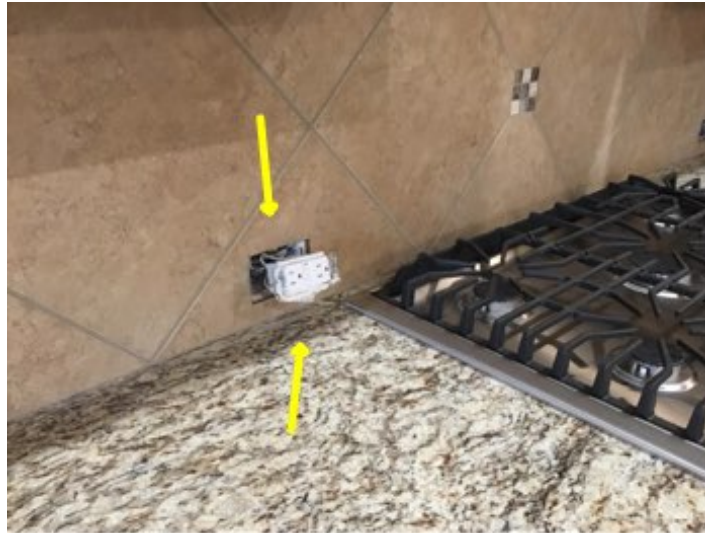
Missing outlet covers in kitchen and master bath

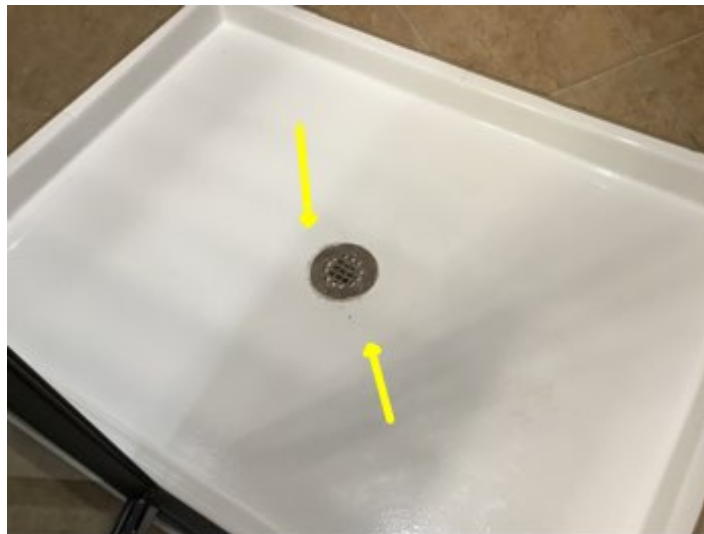
- Vent pipes are noted as **PVC**
- **Drain for shower in master bath was grouted in and should be removable**

Cover for shower drain should be removable

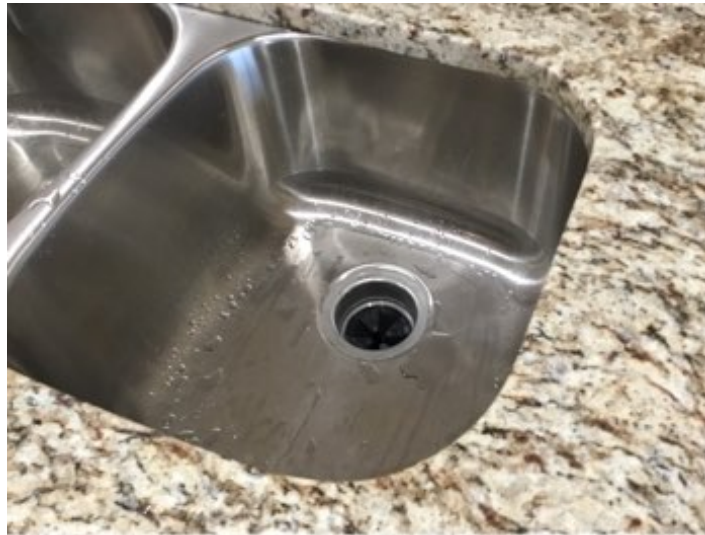
Comments:
• **The unit was vibrating and/or abnormally noisy and should be checked for objects in the grinding assembly**

The disposal appeared to have foreign objects caught in it
